Subject: Site Evaluation  
Prepared For: Anonymous Customer  
Prepared By: Michelle Propst, Performance Engineer  
Date: August 2012

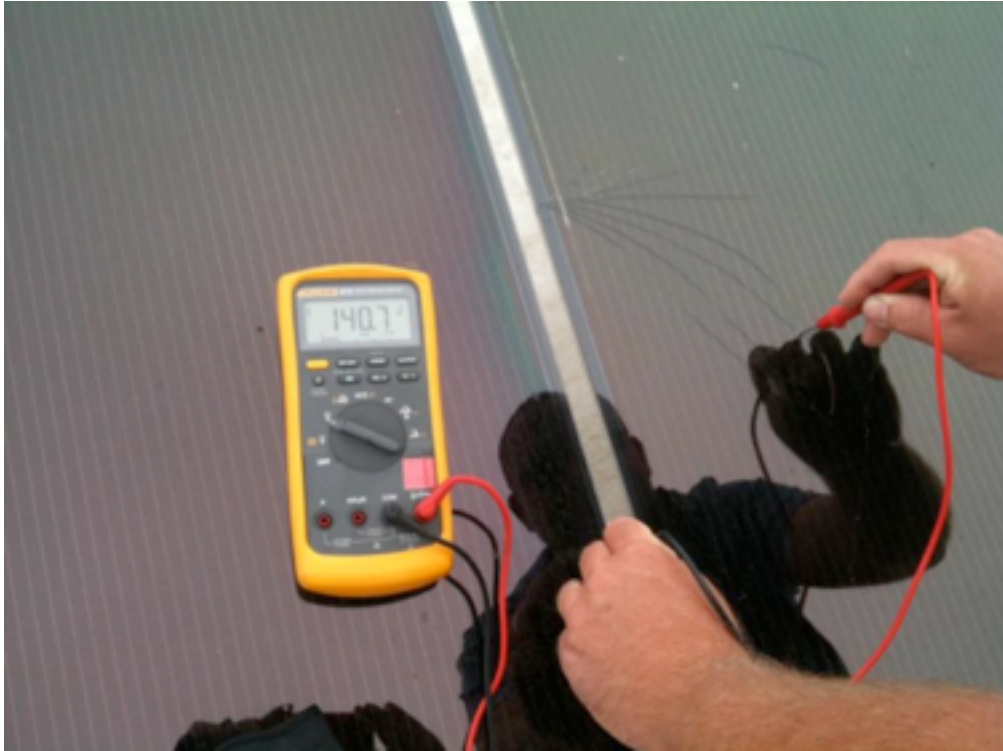
Module breakage occurred due to excessive heating from the buss bar burn on 5 modules. These modules were removed from the strings and the strings were disconnected at the combiner box to reduce any safety hazard. A positive potential was measured from the broken front glass to the rack as high as 200V further supporting the decision to remove these modules from the strings. The locations of these 5 strings which were disconnected are given in the below table.

Fig.1: Example of measured potential between cracked front glass and rack.

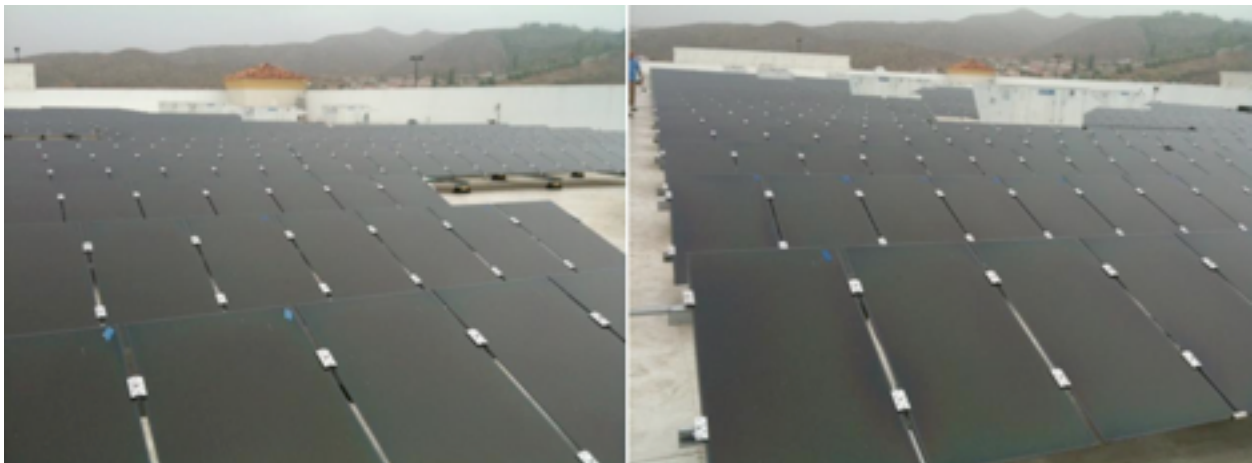
The primary objective of this trip was to determine the underperformance issue of the site. Upon visual inspection of the 4620 modules, it is evident that the site is plagued with buss bar burns. 1003 modules were mapped and tagged with visible buss bar burns. This is equivalent to 22% of the modules but 397 strings are impacted or 95% of the strings on site.

Fig. 2: All bad modules were identified and marked with blue masking tape in the right hand corner.

The buss bar failure rate is in excess of 61% given by: 22% failed modules + expected 50% of remaining modules once current is reintroduced to the strings. These modules are impacting 95% of the strings. Replacement of all the modules at this site as well as the other two identical locations is recommended. All 3 sites should be taken offline until full replacement can be made to eliminate any potential risks.

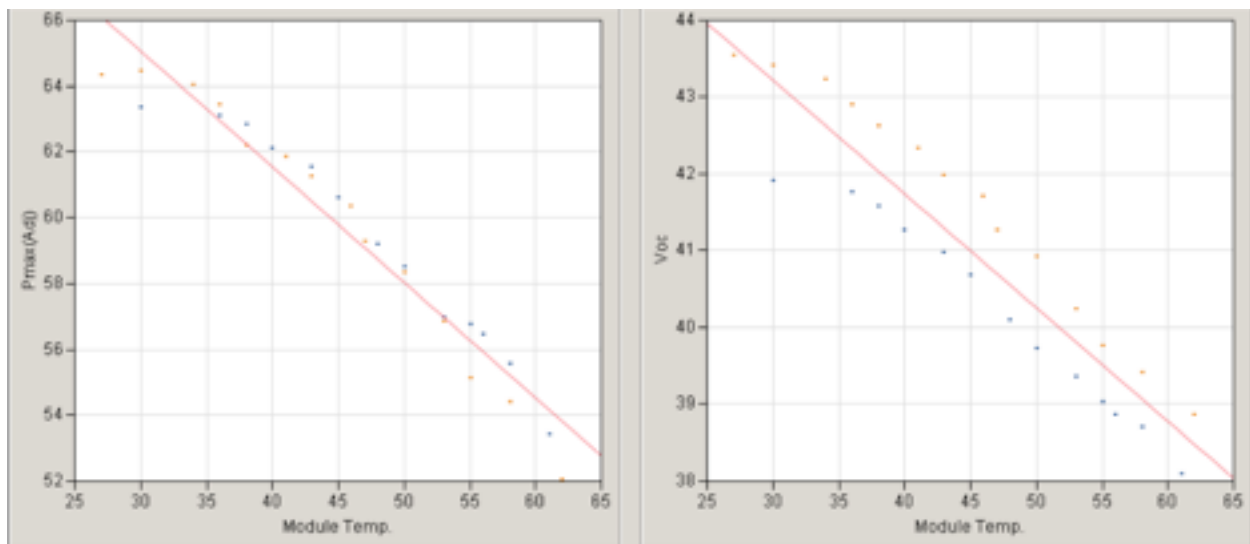
Cell temperatures were measured at 60C-67C, ambient temperature was 37C. 2 modules were cooled to ~30C using iced towels and IV sweeps taken continuously as the modules returned to temperature. Temperature coefficients were calculated as -0.53%/C for Pmax and -0.33%/C for Voc. This high temperature coefficient for Pmax has been attributed to an excursion in the module manufacturers process and since corrected.

Fig. 3- Pmax and Voc Temperature Coefficient, calculated under constant illumination, cooling modules to 30C and continuously sweeping IV curves until the modules returned to normal operating temperature.
